Cyprus Industrial building - Leaking pipe Project

By ENECON Mesogios Ltd

Nicosia, June-July 2016

Plastic pipe inside column created many leaks in below office space.

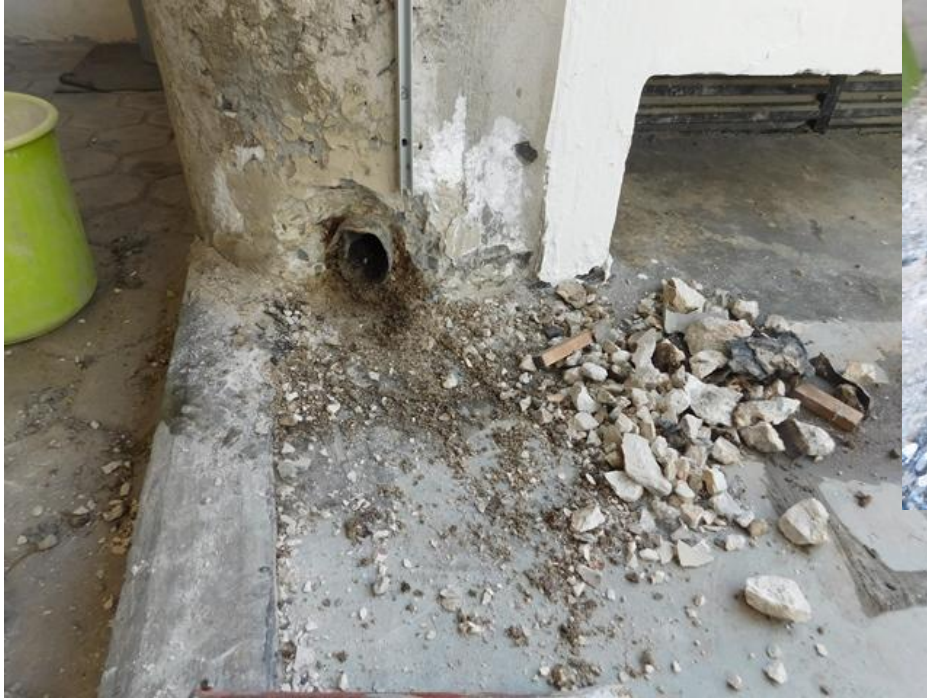
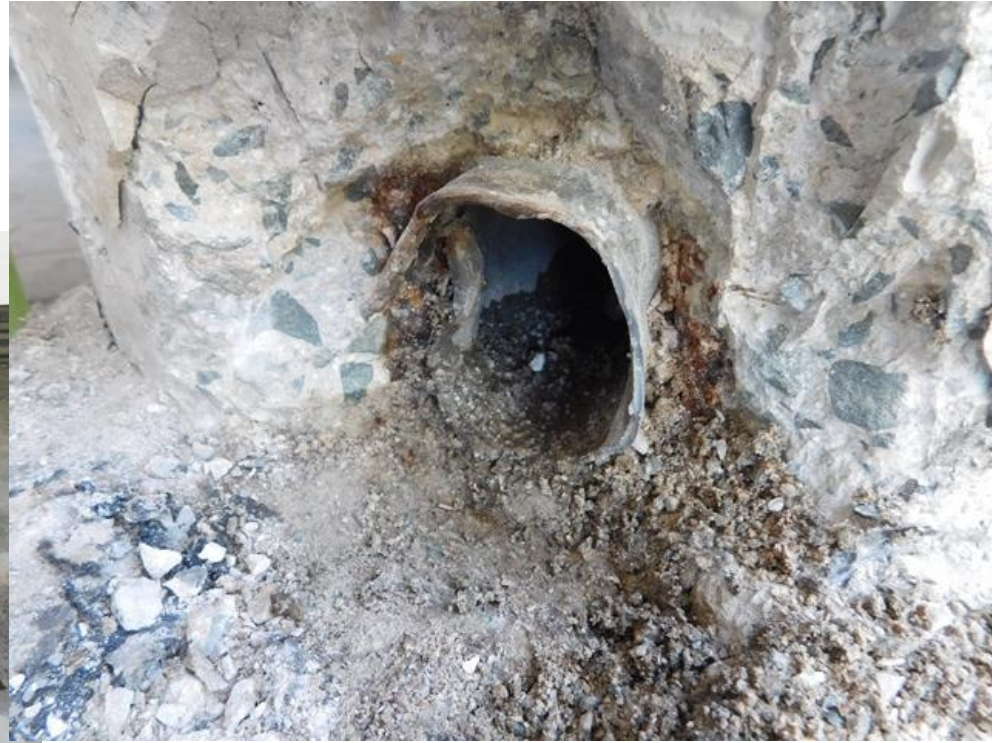
The problem!

The area of the connection of the 2 pipe parts was not done properly and leaks were created especially when it was raining. Due to the limited space, we decided to permanently fit a new connection pipe inside existing with DuraQuartz.
