## 60 Year Old Pump Casings Are Saved By DuraWrap

A major power station in Bavaria had a serious issue with these two 60 year old pump casings. They were in very poor condition – structurally compromised and leaking.

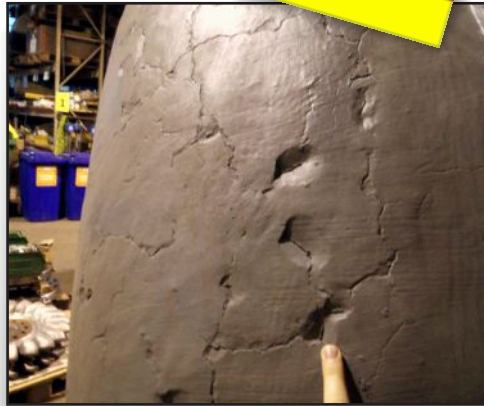
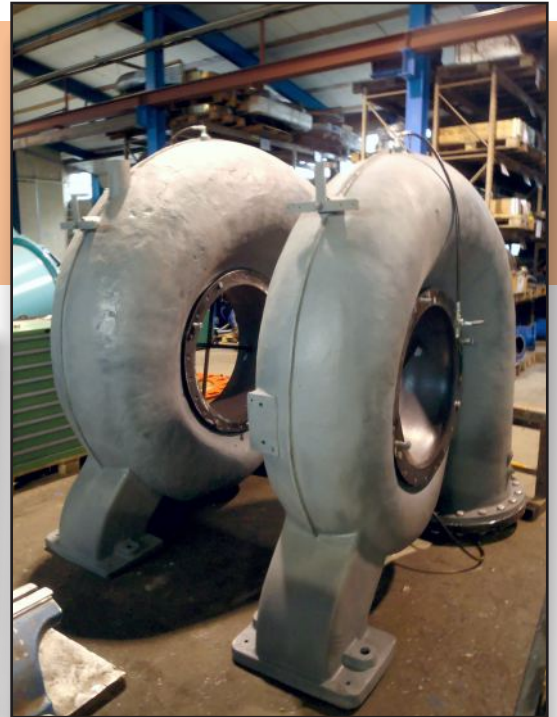
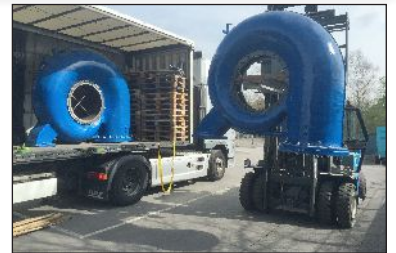
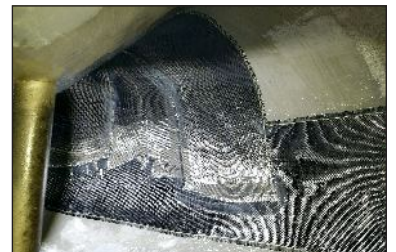
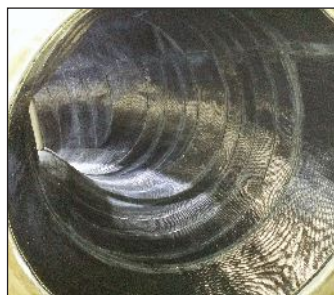
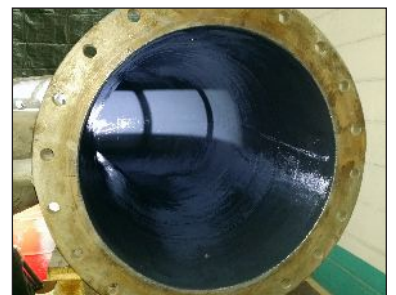
ENECON Germany were called in to see if they could refurbish these casings which weighed about 2 tons each. The power station engineers were worried that due to metal fatigue, the casings would no longer be able to withstand the operating pressures and, at some point, they could fail causing catastrophic damage to the turbine.

The casings were grit-blasted and then **METALCAD DurAlloy** was used to seal the leaks and rebuild all the metal back to the original thickness, shape and contour.

The **METLACLAD DuraWrap** system was then applied on the *interior* of the pump casings in order to reinforce and restore their structural integrity.

**CHEMCLAD XC** was applied over the **DuraWrap** to provide a smooth surface finish in order to restore/improve the components' pumping efficiency.
