Cyprus Industrial building - Leaking pipe Project

By ENECON Mesogios Ltd

Nicosia, June-July 2016

Plastic pipe inside column created many leaks in below office space.

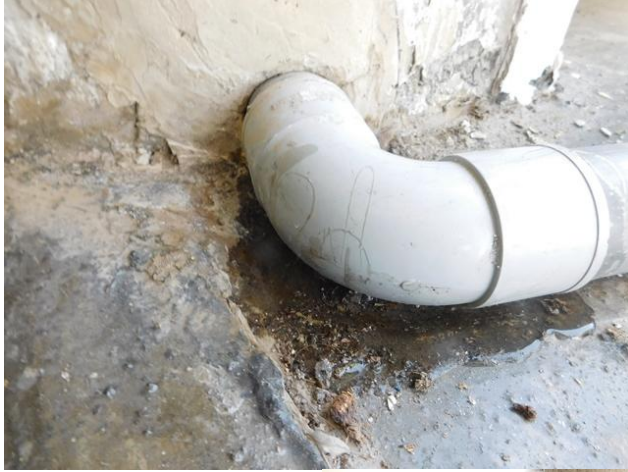
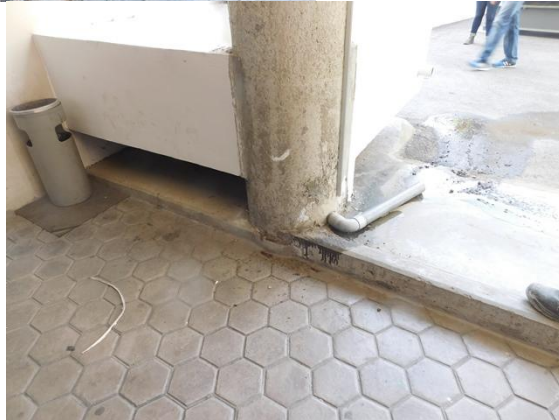
Steps of repair

The problem!

The area of the connection of the 2 pipe parts was not done properly and leaks were created especially when it was raining. Due to the limited space, we decided to permanently fit a new connection pipe inside existing with DuraQuartz.

Our repair consisted of:

- Uncovering related column (done by contractor)
 - Clean all loose wall material and removed broken pipe connection
 - Primed exposed rebar with ENESEAL CR
 - Do repairs with DuraQuartz
 - Sealed with ENESEAL HR
-

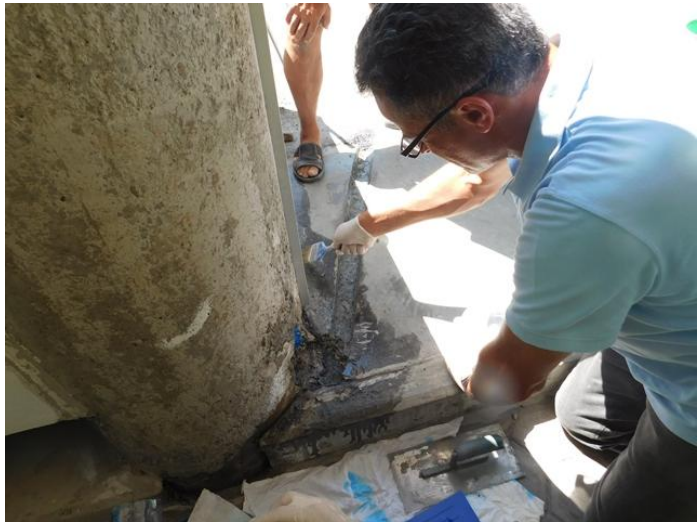
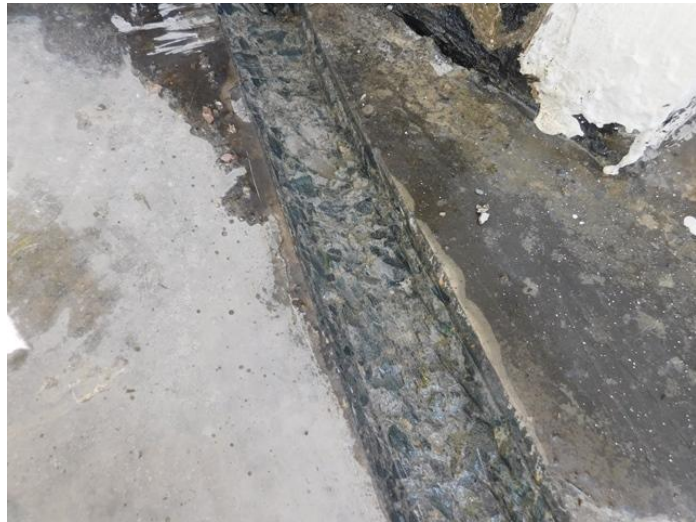
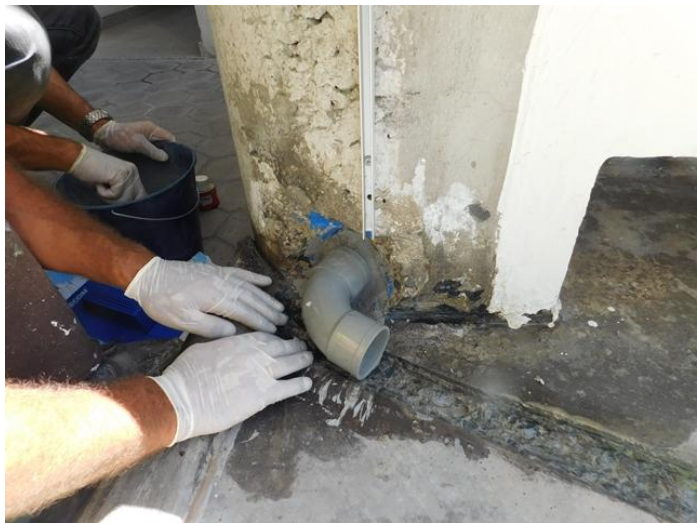
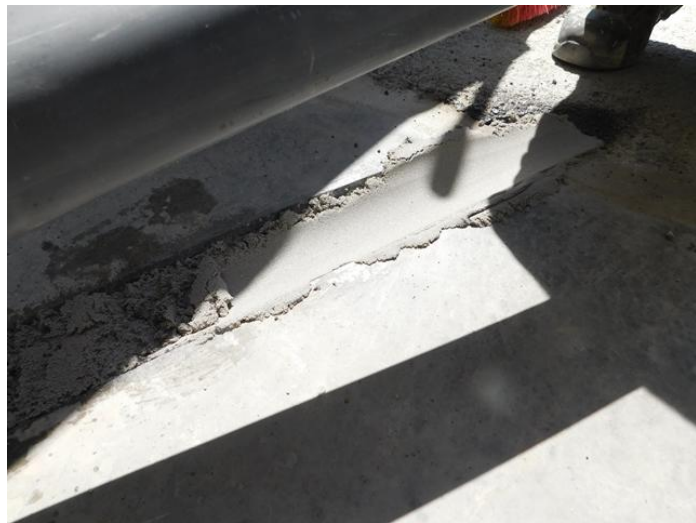
Additional cracked areas on column was rebuild with this 3 component polymer

Everything was sealed with ENECRETE DuraQuartz by ENECON.
